WRDC-TR-89-4055

COMPENDIUM OF FRACTOGRAPHIC DATA FOR COMPOSITE
MATERIALS

INTERIM REPORT
Covering 9-22-86 through 10-31-88

C. Hua
M. Yamashita
Boeing Advanced Systems
P.O. Box 3707
Seattle, WA 98124

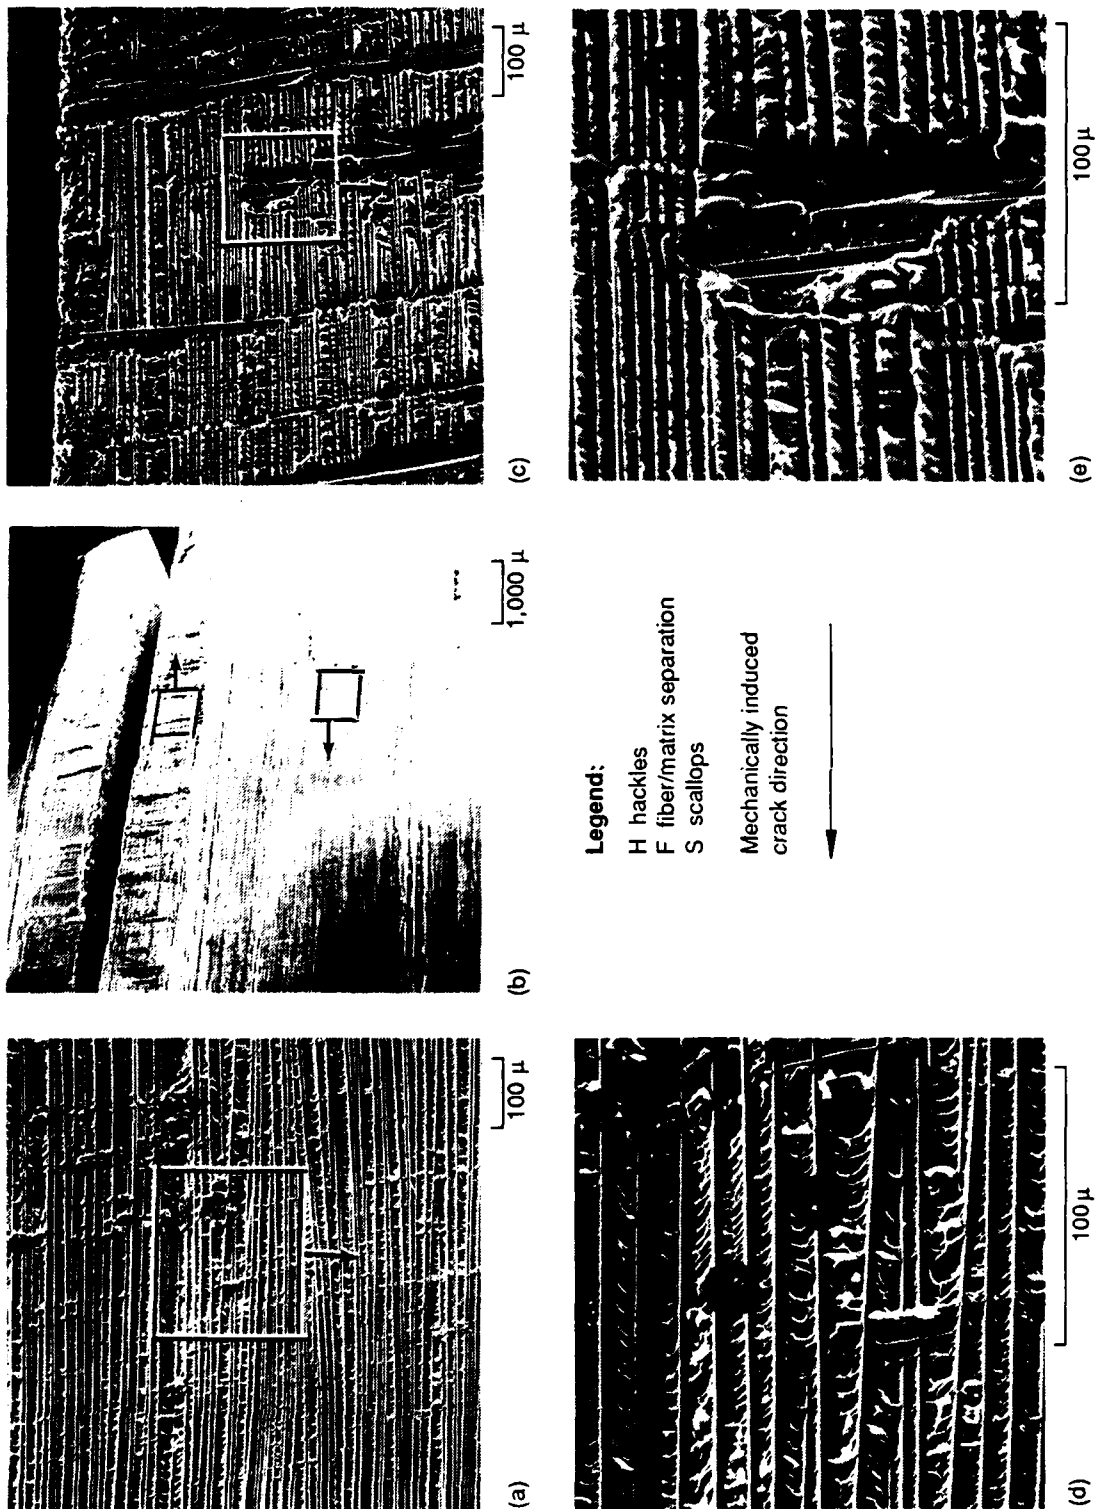
Interlaminar Mode II Shear, 270°F. Visual examination revealed a fracture with smooth and glassy surface on one of the mating sides and rough and dull on the other (Fig. 4.4-28). This was similar to the fracture surfaces created at room temperature. The glassy surface exhibited mostly of scallops (with some hackles) (Fig. 4.4-29), and the

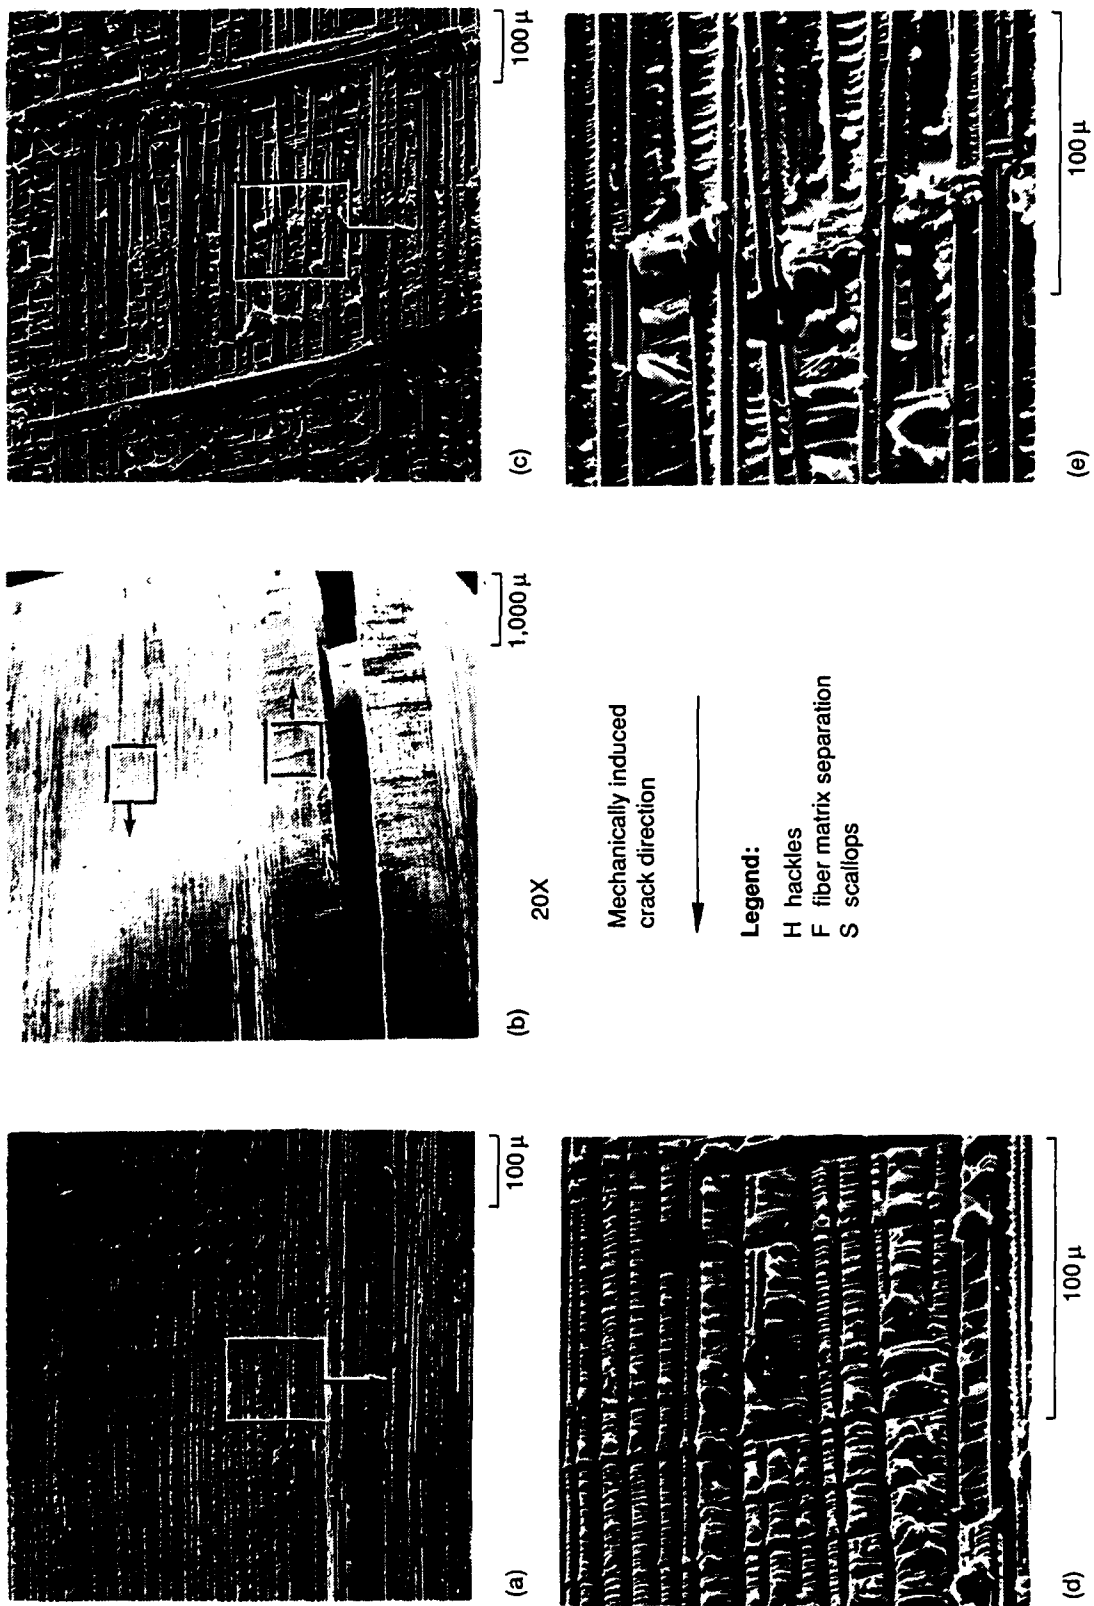
Figure 4.4-30. SEM Fractographs of Interlaminar Mode II Shear, 270 F/Dry Creep Fracture Showing Rough Surface

rough surface consisted mostly of hackles (with some scallops) (Fig. 4.4-30). Optical and SEM analyses showed no significant features to distinguish the RT and 270°F creep specimens.

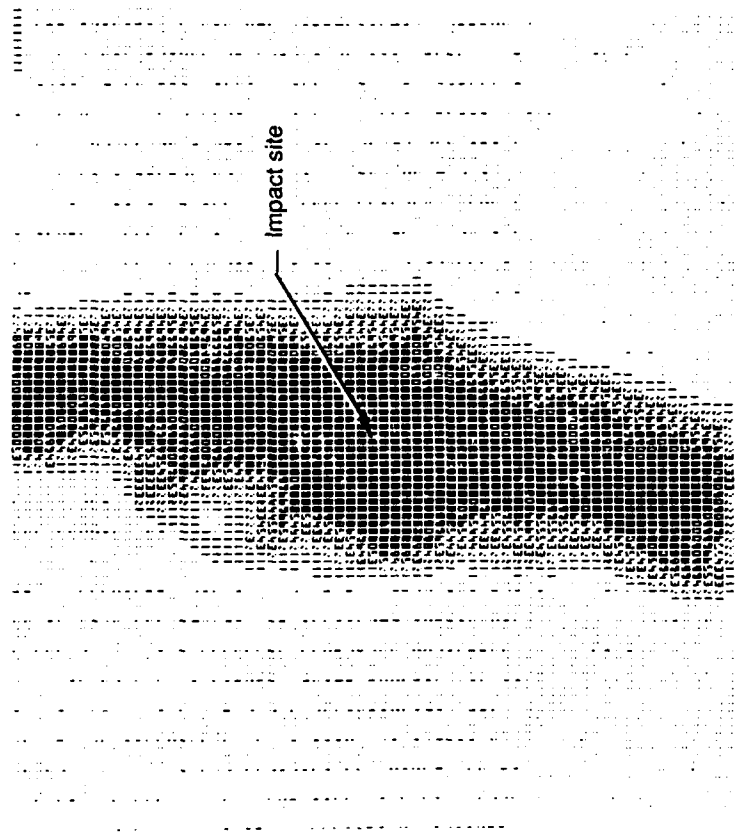
Figure 4.4-37. Extent of Impact Damage Identified by Through Transmission of Ultrasonic (TTU) Scan of Impact Specimen (AS-4/3501-6)

Compression After Impact. Visual inspection revealed extensive buckling damage around the point of impact. Failure of the panel occurred in a band approximately 1.0 to 1.5 inch wide across the full width of the panel (Fig. 4.4-37). TTU indicated a

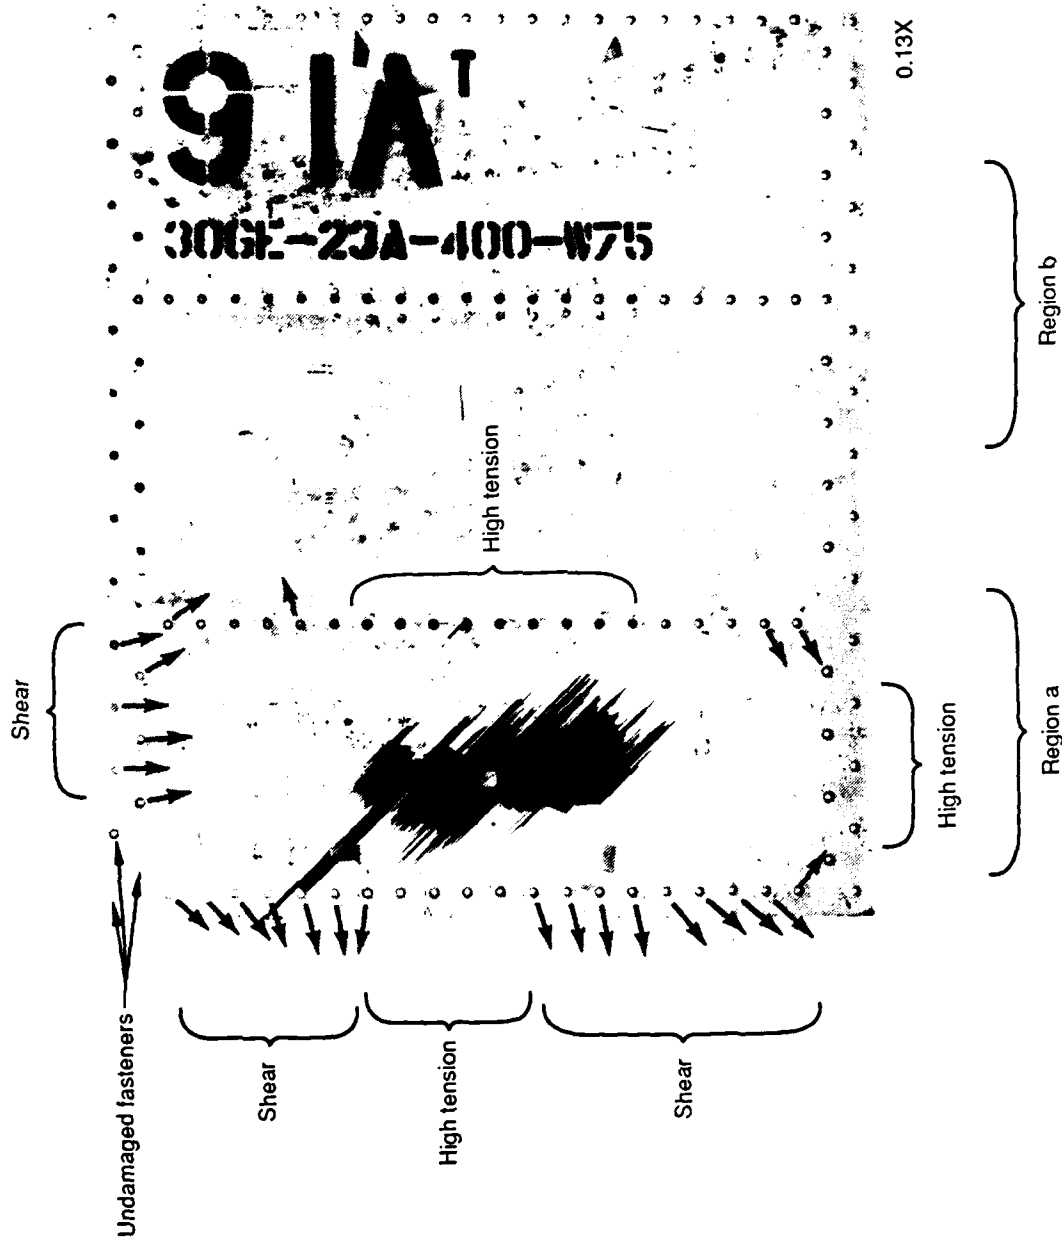
Figure 7.4-5. Mapping of the Fastener Hole Damage

The fastener hole damage indicated that Region A of the test panel was subjected to tensile and shear loading. Region B showed no sign of damage suggesting that it was fixed to some type of structure. The major damage on the panel appeared to have been
